# Special Report 86-29

Cold Regions Research &  
Engineering Laboratory

## *Blistering of built-up roof membranes* *Pressure measurements*

Charles Korhonen

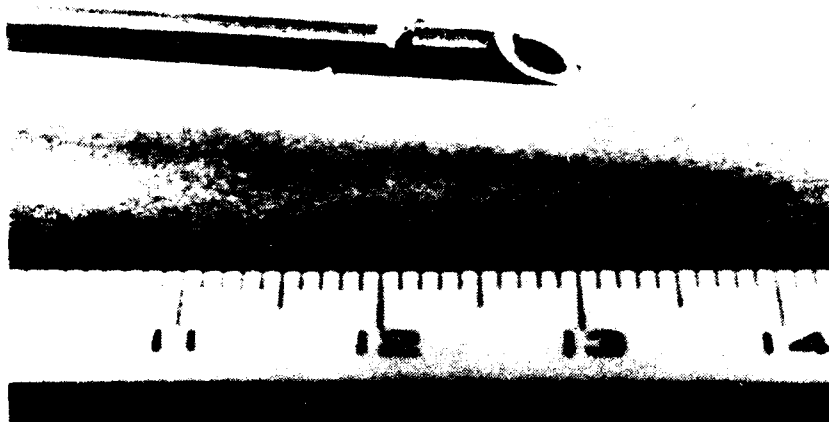
Figure 2. Close-up of the side-vented needle fabricated from 1/8-in. O.D. stainless steel tubing.

Internal pressures were measured by inserting a hypodermic-type needle through the wall of a blister (Fig. 1). For this operation a side-vented needle (Fig. 2) worked best. Needles that were open only at the end became plugged with bitumen. The needle was sealed to the pressure sensing port of the Microswitch sensor. The sensor's other port was connected to a plastic tube vented in a bottle of desiccant at atmospheric pressure. This prevented moisture from entering the port and damaging the sensor.

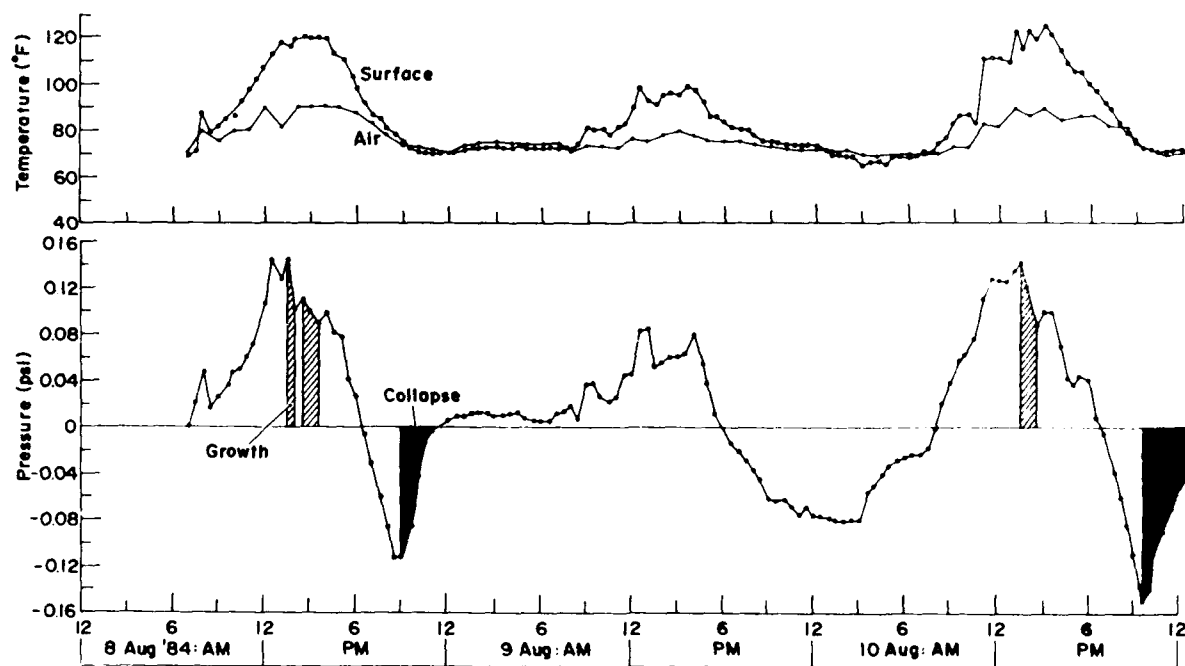
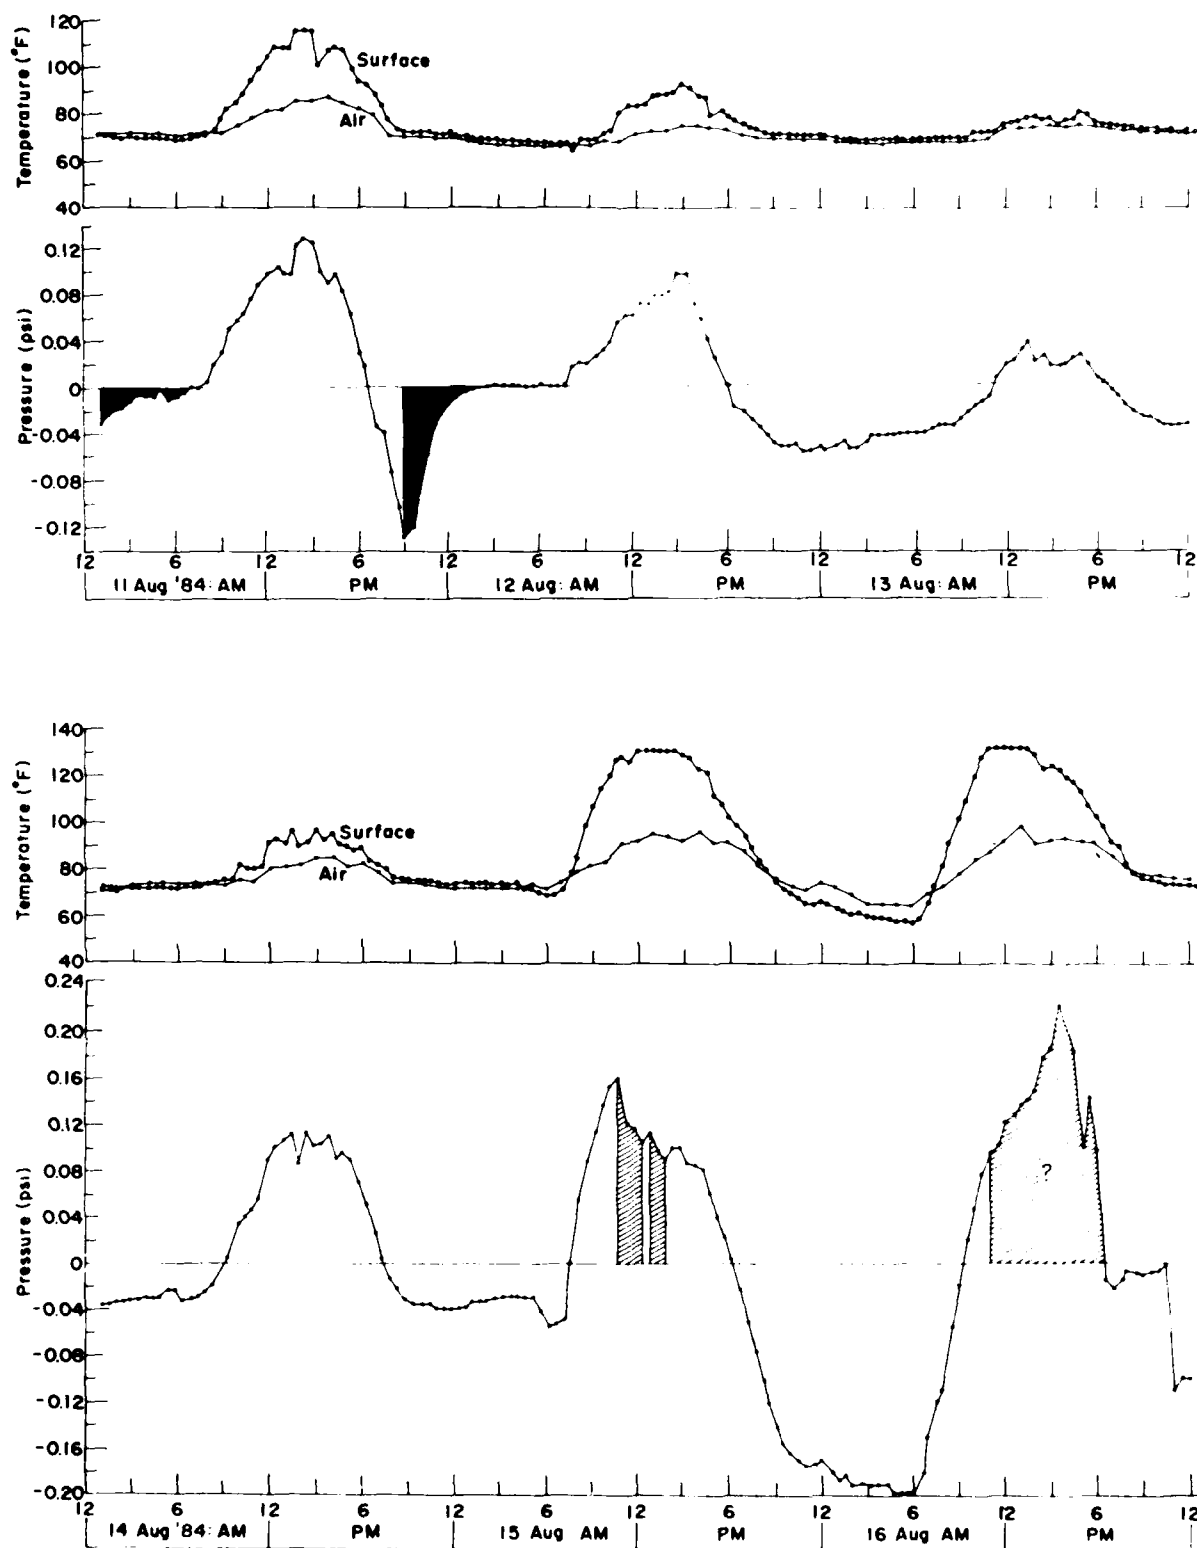
Figure 7. Temperatures and pressures for the Devens blister.

Figure 7 (cont'd). Temperature and pressures for the Devens blister.

Surface temperatures and internal pressures for each blister are shown in Figures 7-11. As can be seen, changes in roof surface temperature reflect changes in blister pressure. The pressures range from positive (above atmospheric pressure) during the heat of the day to negative (partial vacuum) during the cool of the night. If a blister were completely sealed and rigid, its internal pressures could be determined by referring to Figure 12, which was derived from the ideal gas law.

In over thirty days of field testing I found obvious indications of blister growth on only four days. On 8 August (Fig. 7), for example, the roof surface temperature at Fort Devens rose to a high of 120°F at 2 pm and held there for two hours. The pressure, meanwhile, rose to a high of 0.14 psi at 12:30 pm, dropped to 0.13 psi at 1 pm, and rose again to 0.14 psi at 1:30 pm. At 2 pm, when the surface temperature was still high, the pressure rapidly fell to 0.09 psi. This rapid drop in pressure, when it should have remained high, must be caused by an increase in the volume of the blister, as opposed to a sudden venting. In other words, the blister grew.

Nighttime temperatures significantly affect the daytime growth of a blister. During the evenings of 8, 10 and 11 August (Fig. 7) the roof surface temperatures remained at approximately 70°F from 11 pm until morning. The vacuum, instead of also remaining stable, began to rise rapidly shortly before midnight on each night. In these cases the blister walls were not rigid enough to resist the vacuum, so they partially collapsed, as indicated by the rapid pressure change. Collapses such as these inhibit growth the following day by reducing the amount of air that is drawn into a blister at night. For example, on the day following the 10 August collapse, no growth (that is, no sudden drop in pressure) was evident even though the temperatures were sufficiently high.

When nighttime collapses do not occur, on the other hand, the potential for growth is increased. On the evening of 15 August (Fig. 7), for example, the blister vacuum steadily increased as the temperature dropped. No sudden pressure change, indicating a collapse, was evident, so air must have been drawn into the blister all night. Consequently, daytime blister pressures were considerably higher on 16 August than on 15 August even though surface temperatures were essentially the same on each day. Of the four days of growth, the most growth appears to have occurred on 16 August (Fig. 7).

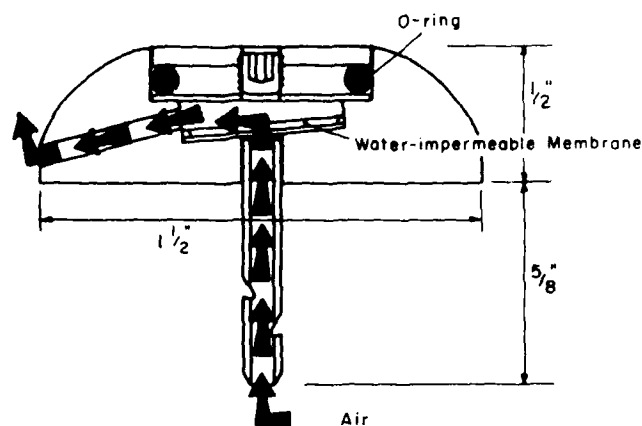
Figure 17. Blister pressure relief valve.

maintenance might not be required at all. To stop blister growth, I devised a pressure relief valve (Fig. 17). It consists of a membrane, permeable to air but impermeable to liquid water, enclosed in a small housing attached to a needle. I tested this device by inserting the needle into a blister. Figure 18 shows that it worked as planned. No pressure developed after the valve was installed. Because the pressure valve is small, its vulnerability to damage from foot traffic is also small. I walked on it several times on a cool day without dislodging it from the roof. In fact, when it was necessary to remove it, I had to pry it loose with a screwdriver. Although more field testing is needed, these devices appear to have the potential to "kill" blisters when they are small. An application for Army patent rights has been filed.

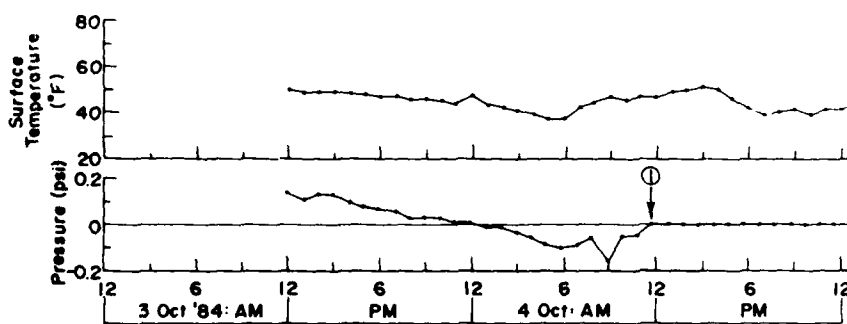
Figure 18. Temperatures and pressures before and after valve was installed (1) into blister.

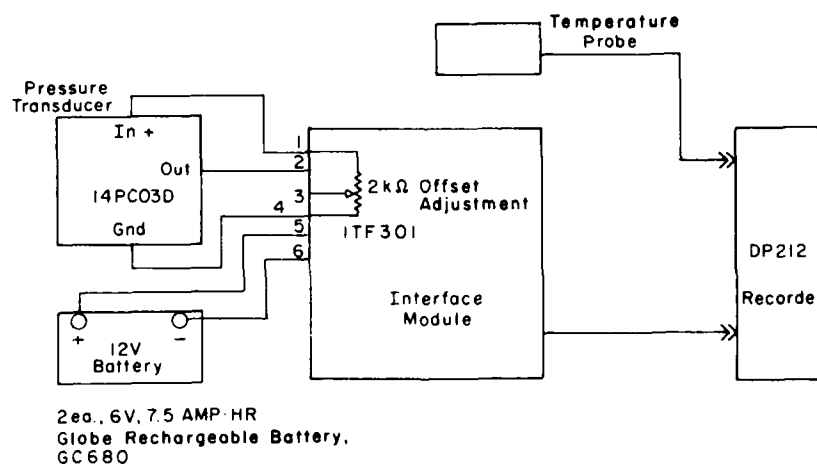
Figure A1. Data acquisition system.

An 8.0-V DC supply voltage was selected to produce a transducer output of exactly 1.0 V per psi, with a 3.5-V offset at ambient atmospheric pressure (Fig. A1). A 2-K $\Omega$ , 22-turn resistance potentiometer,\* connected across the transducer's voltage supply, was adjusted to produce a transducer offset of 0.50 V at atmospheric pressure. This allowed pressures to be read in the range of -0.50 psi to 1.5 with a 0-2.0 V output.

The DP212 was used with an Omnidata Model 1TF301 Interface Module. The transducer was directly connected to a terminal strip on the interface module. An external 12-V battery was connected to the terminal strip also. An adjustable voltage regulator contained in the interface module supplied the 8.0 V required for pressure transducer excitation. The module also contained a voltage divider so that the transducer output could be matched to the 0-2.0 V range expected by the Datapod. (The user must refer to the 1TF301 Interface Module manual for these range and voltage adjustments.) The pressure transducer was powered only on demand by the Datapod, which controlled a relay in the Interface Module. The transducer was excited just prior to recording data to conserve battery power. (The rate of data collection is user programmable with an internal switch bank, explained in the user manual for the Datapod Model DP212.)
